Feuling Camplate Tools

Keep calm under pressure

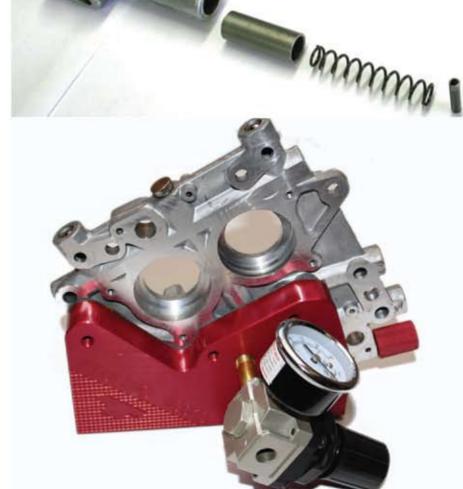
The arrow indicates the camplate oil port where you can feel for air leakage.

with Feuling's camplate pressure test tool #9010. We recommend pressure testing the camplate anytime it is out of the engine. It is important to test the camplate prior to disassembling the relief valve so you know how it is currently performing. The Feuling tool provides an ideal workstation for servicing the camplate.

To service the relief valve, remove the roll pin, spring and relief valve plunger. Feuling tool #9000 can be used to hold the spring down while you remove/install the roll pin. Inspect and clean the camplate bore and plunger valve. Use sand paper or an abrasive pad to remove any debris or burrs, then clean and reassemble the plunger valve using a spray lubricant on the bore and valve. To re-seat the

plunger valve, hold it down with a punch, turn up the air on the tool regulator while holding down and centering the plunger with the punch, then give it a good whack with a hammer. This process will create a new seat and may need to be performed multiple times in order to obtain the desired results.
